Woodlake Dam and Outlet Works Evaluation

October 27, 2025

WDL-2025-10-18

Executive Summary

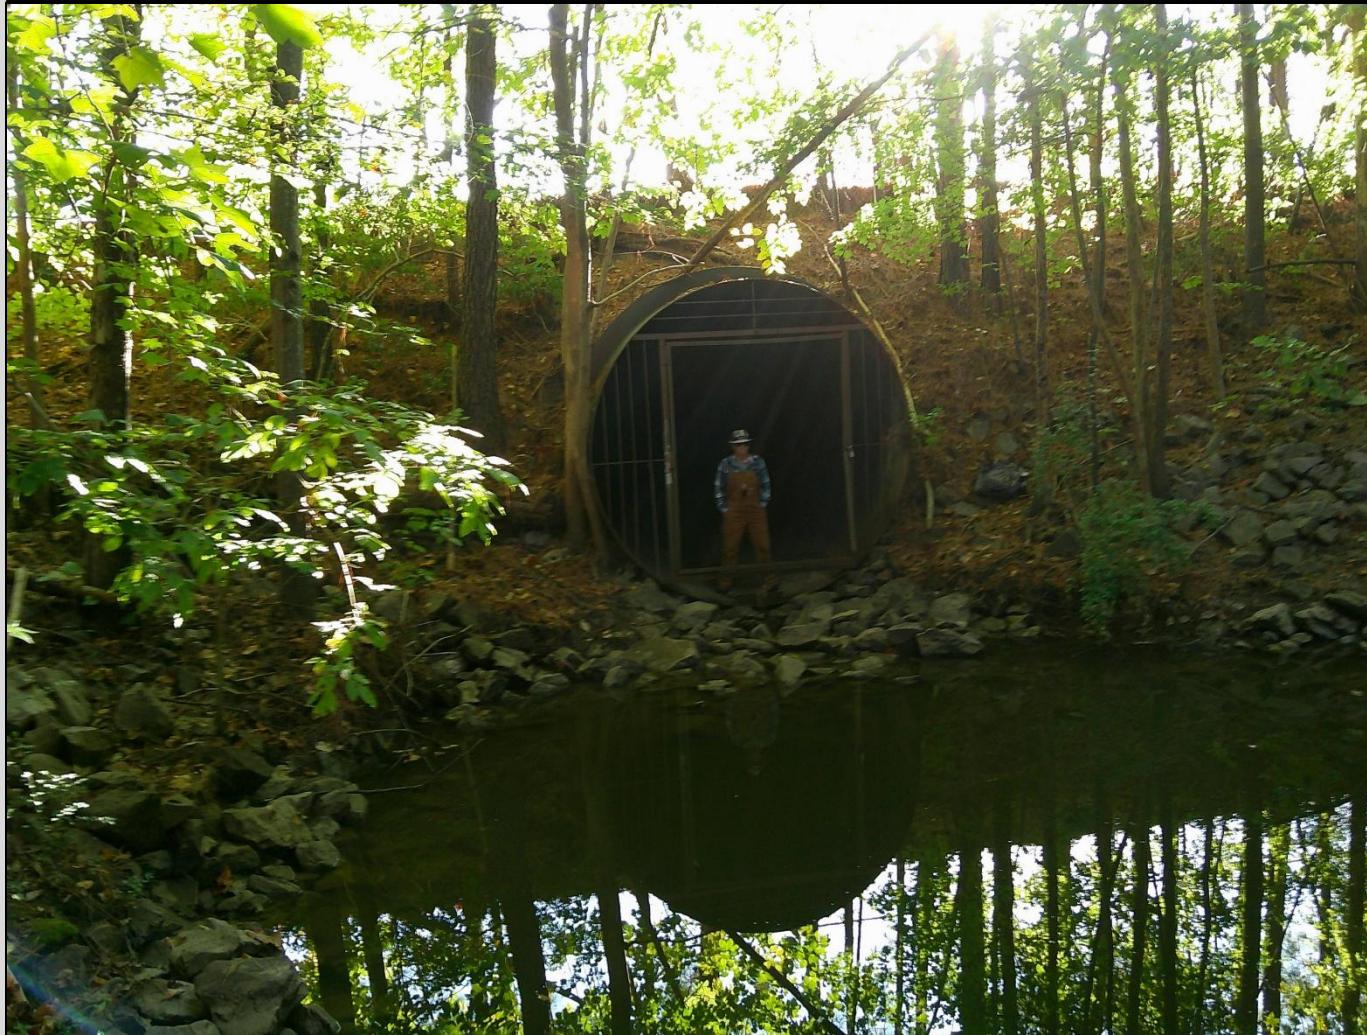
Outfall Overall Comments: The riprap lined stilling basin outfall appeared to be in really good condition. There did not appear to be any new (or significant) plumes of sediment in the stilling basin.

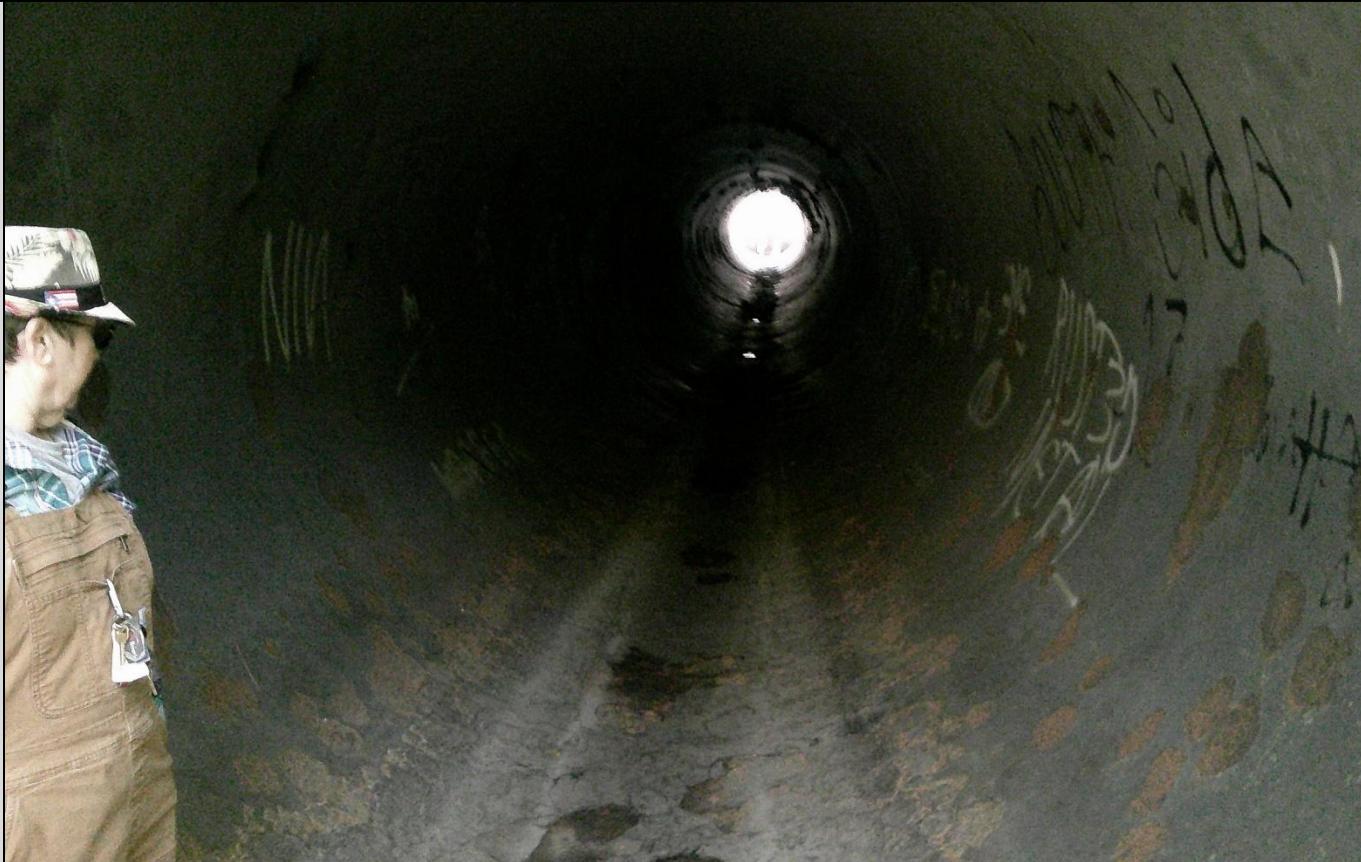
Pipe Overall Comments: Overall, the inside of 114" dia carbon steel spillway pipe [Note: I'm not a metal pipe expert, but this pipe looks like a carbon steel (i.e., a carbon-iron composite) pipe.] appeared to be in reasonable condition. This pipe appeared to be manufactured in 40-ft sections, where each 40-ft section appeared to be comprised of four ten-foot long segments, which were plant-welded on the inside and outside. Some undermining under the last two-feet of pipe was apparent due to hollowness under the pipe. This undermining issue should be addressed [see Sheets ER-3f and ER-3g]. There was no evidence of leakage into the pipe. Nor was there any indications that seepage was occurring around (and outside) the pipe. Overall, the pipe appeared to be in reasonable condition.

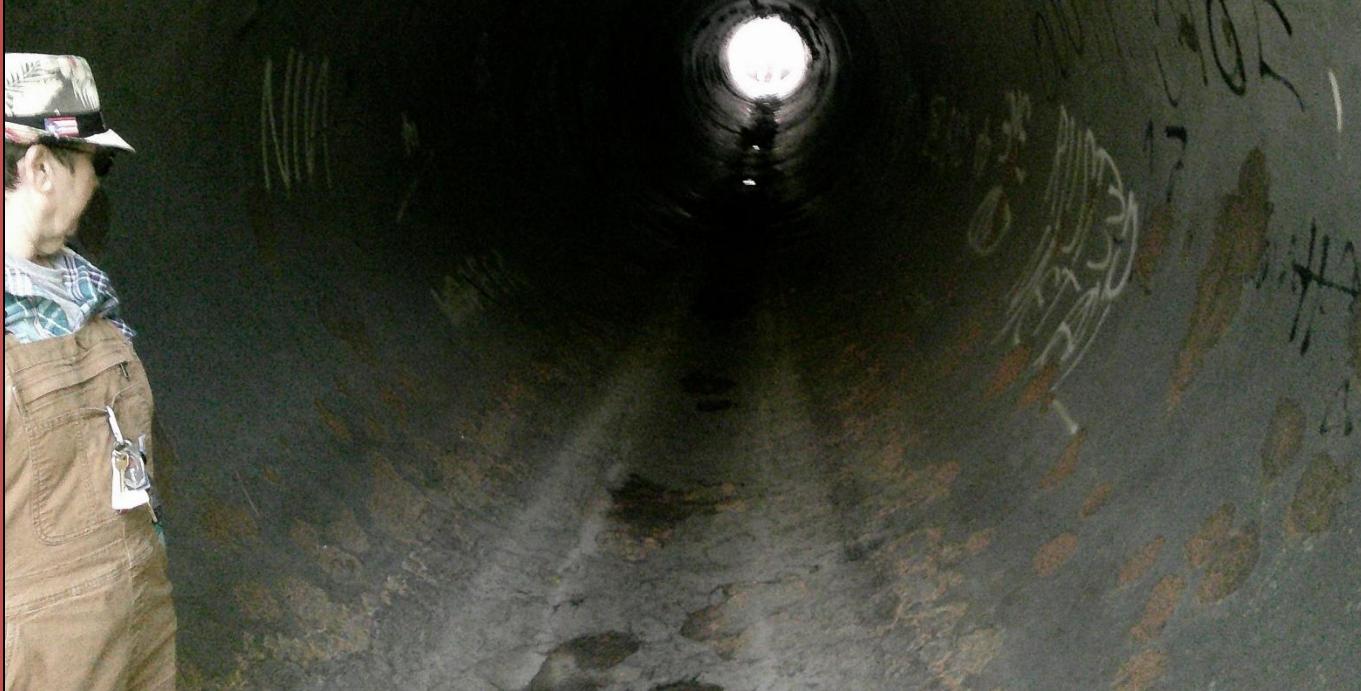
Pipe Material Condition Comments: At installation, the 40-ft pipe sections appeared to have been field-welded inside (and, presumably) outside. Given that these field welds are probably the weakest connection points, obvious rusting/corrosion at those connections was noted [see Sheet ER-2c]. It should be noted that there were many instances where the coating on the pipe was gone or had begun to peel away. Corrosion was noted at multiple locations in the flowline [see Sheet ER-2d] (and elsewhere). The pipe is $\frac{1}{2}$ " thick; at its worst, the corrosion in the flowline appeared to have eaten away approximately $1/16$ " (6%) of the steel. Scraping, chemical cleaning, and recoating of the entire inside of the pipe (and the two risers) is recommended to be performed within the next few years (perhaps, even, the next two- to three-years). This work will be a time-consuming and expensive process. It's recommended that, within the next twelve-months, the HOA consult with a carbon steel pipe manufacturer concerning the methods required and timing for this crucial work. Concurrent with this, it's recommended, too, that the HOA consult with a metal pipe expert to look at the pipe itself and even make recommendations on a good contractor to perform any required maintenance work (i.e., scraping, chemical cleaning, coating, etc.).

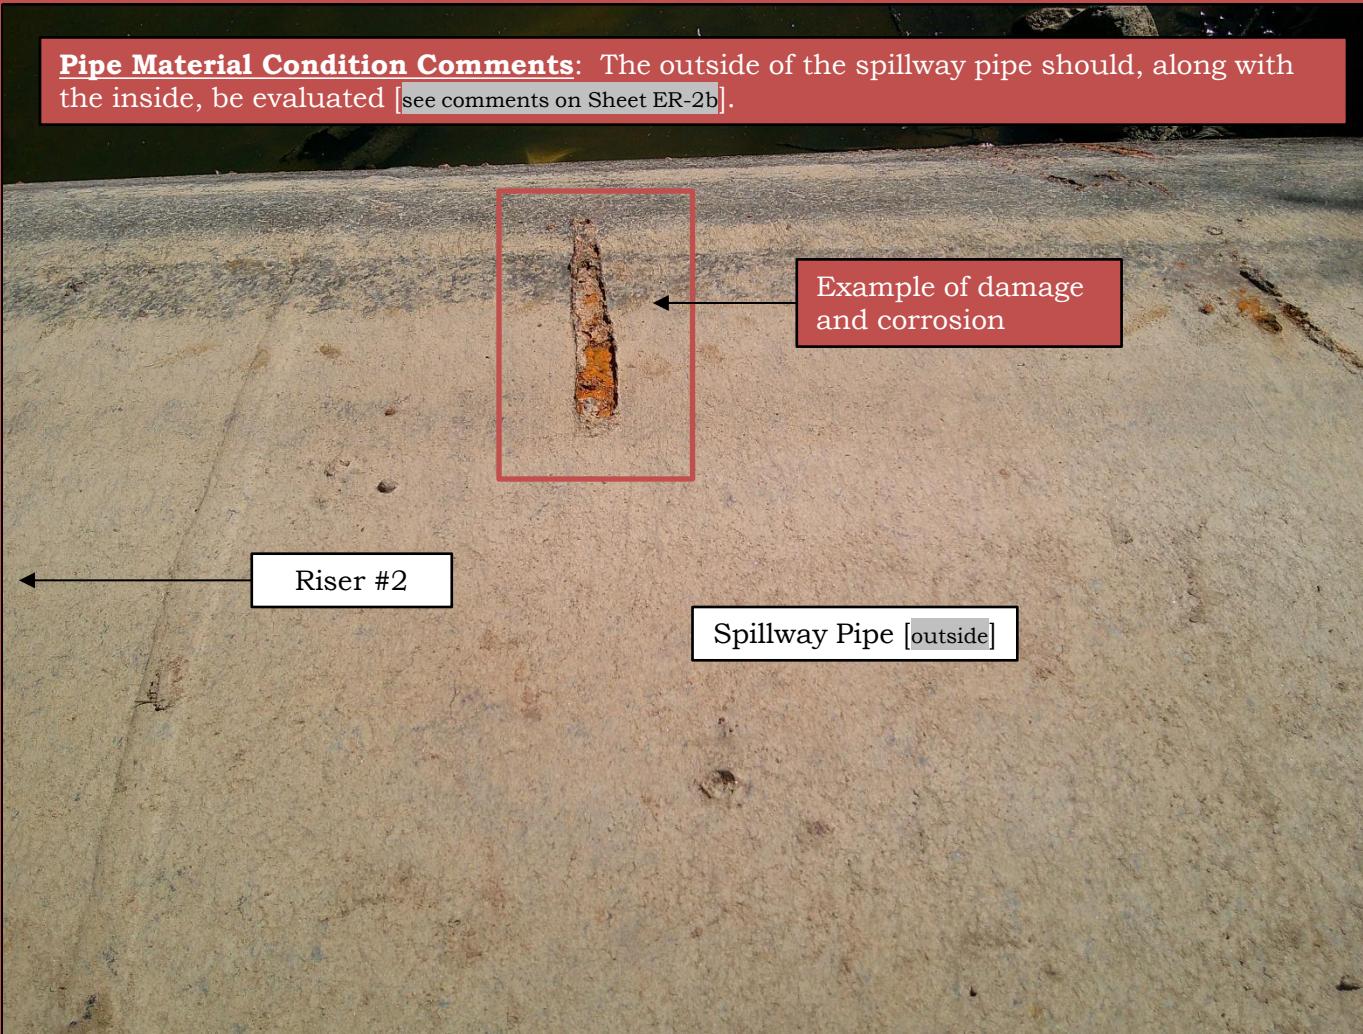
Pipe Material Condition Comments: The outside of the spillway pipe should, along with the inside, be evaluated [see comments on Sheet ER-2b].

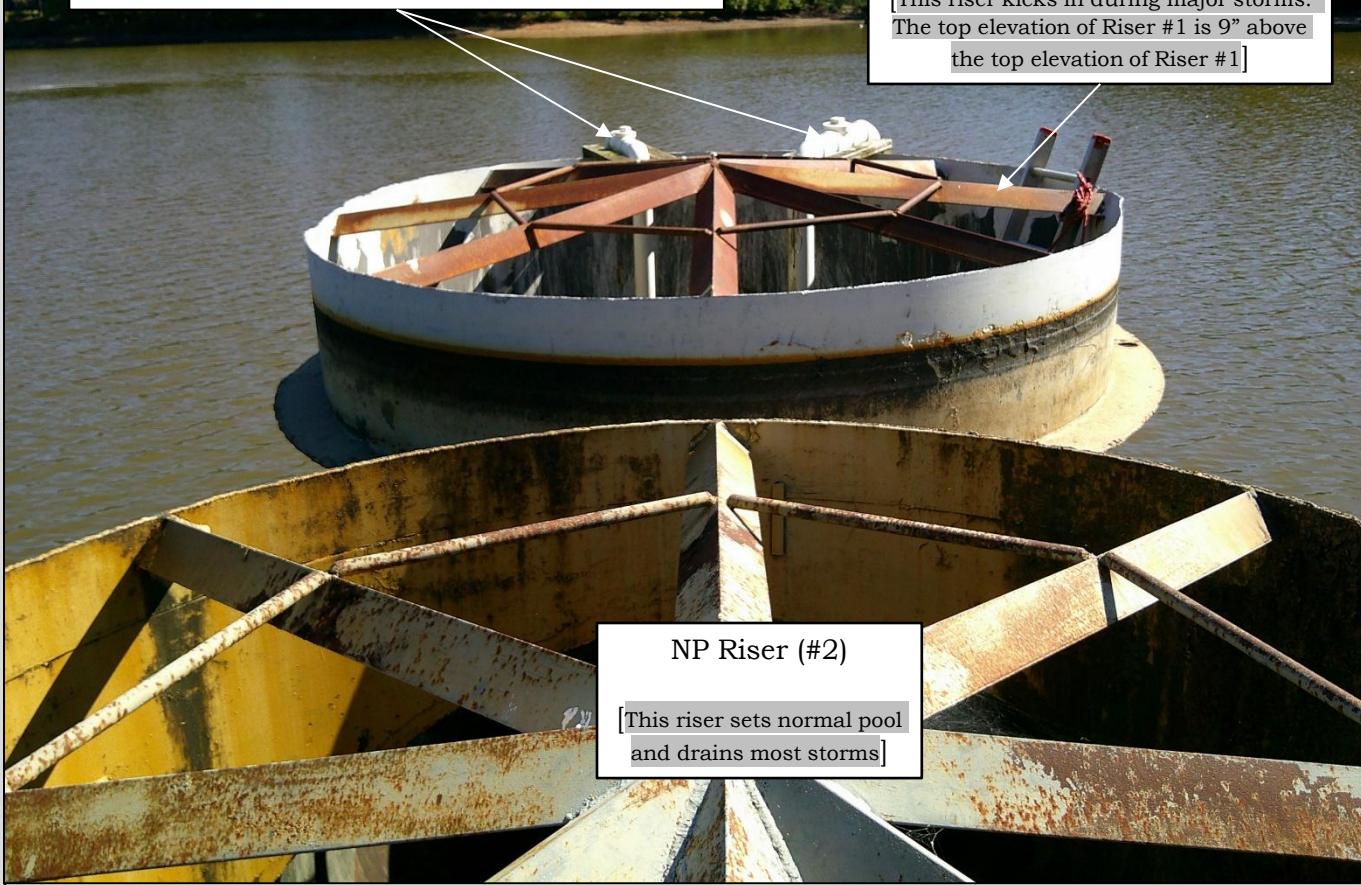
Flood Riser (#1)

It should be noted that Riser #1 included a bottom drain, which went dysfunctional many years ago. This malfunctioning bottom drain does not appear to be leaking.

[This riser kicks in during major storms.
The top elevation of Riser #1 is 9" above
the top elevation of Riser #2]

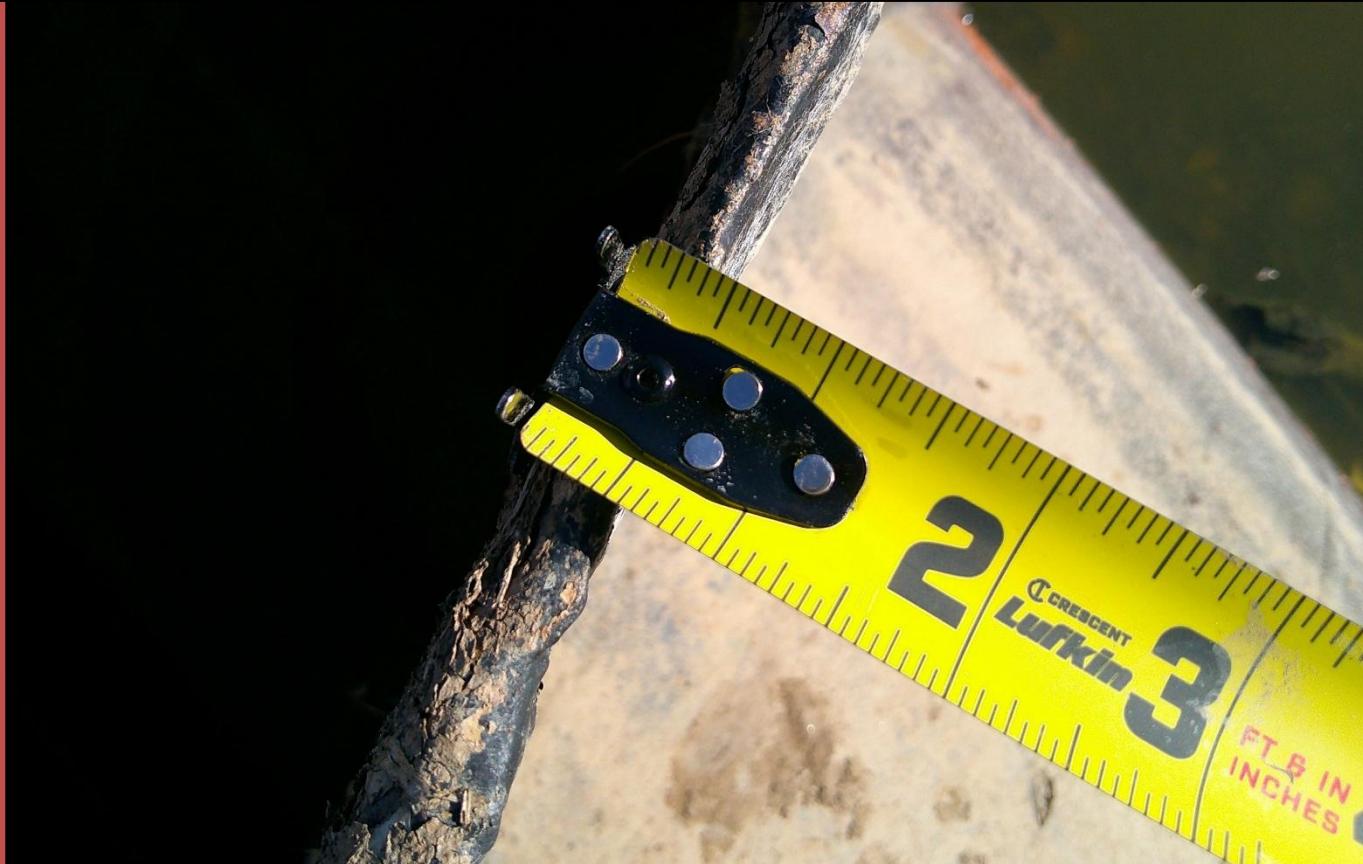
Pipe Material Condition Comments: The riser pipes, like the spillway pipe, are $\frac{1}{2}$ " thick. When measuring the thickness of Riser #2, the thickness had been corroded/eroded/worn down to $\frac{1}{4}$ ", which is 50% of the pipe material. To me, this material condition feels worse than the inside (and, perhaps, the outside) of the pipe. Like with the spillway pipe, it's recommended that, within the next twelve-months, the HOA consult with a carbon steel pipe manufacturer concerning the condition of the two riser structures. Concurrent with this, it's recommended, too, that the HOA consult with a metal pipe expert to look at the pipe itself and even make recommendations on a good contractor to perform any required maintenance work (i.e., scraping, chemical cleaning, coating, etc.).

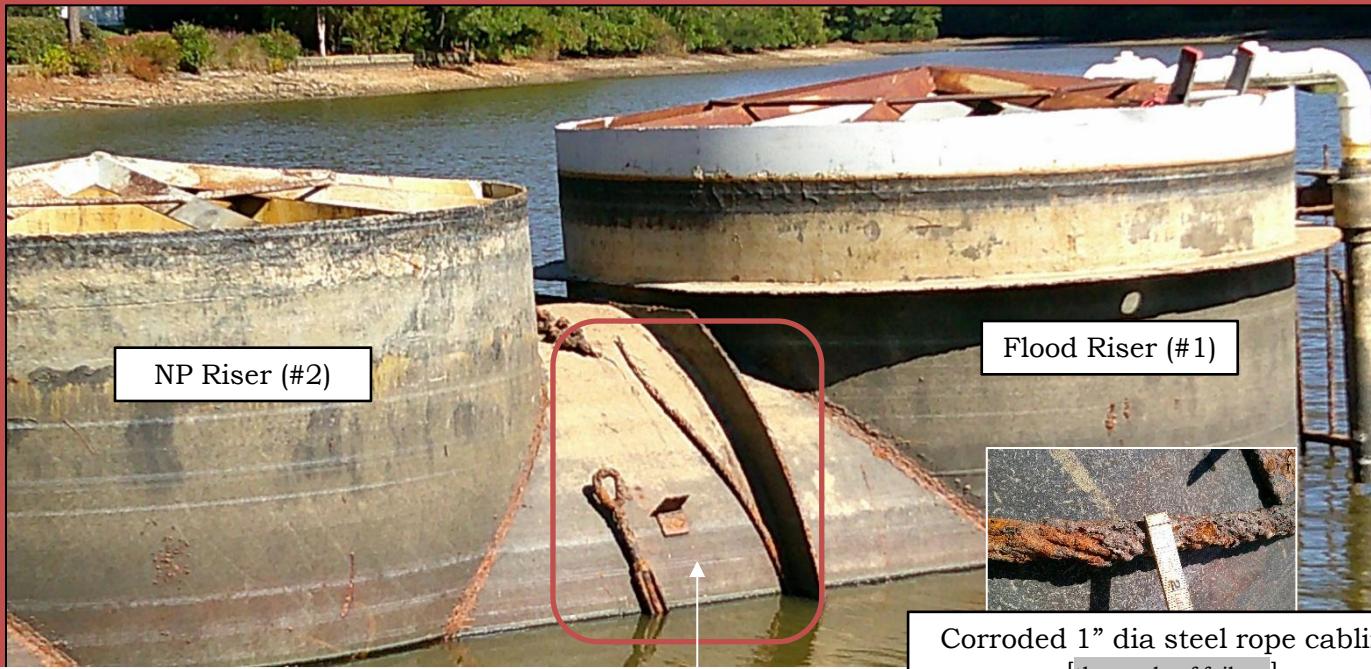
The purpose of this anchoring system is to anchor the spillway to the concrete cradle to keep the spillway from floating during large events.

The previous anchoring system [see “assumed” configuration on Sheet ER-4b] was comprised of steel items, which failed due to corrosion. Of course, what was installed previously could be implemented again. Doing so, however, will, eventually, result in a similar failure. It’s recommended that alternate materials, which are less subject to corrosion, should be explored. An example would be the use of *Amsteel Blue* [see Sheet ER-4c], which is a synthetic rope that’s used in many marine applications and that boasts much greater strength than steel cabling. For other possible alternatives, see Sheets ER-4d – ER-4f.

Replace the failed outlet works anchoring system.

Note: Before any replacement system is explored, the lake will need to be drained down approximately 4-ft more than what’s shown in the photo above so that the concrete cradle and structural connection (e.g., base plates, anchor posts, etc.) can be examined and evaluated. Additional work to this connection may be required.

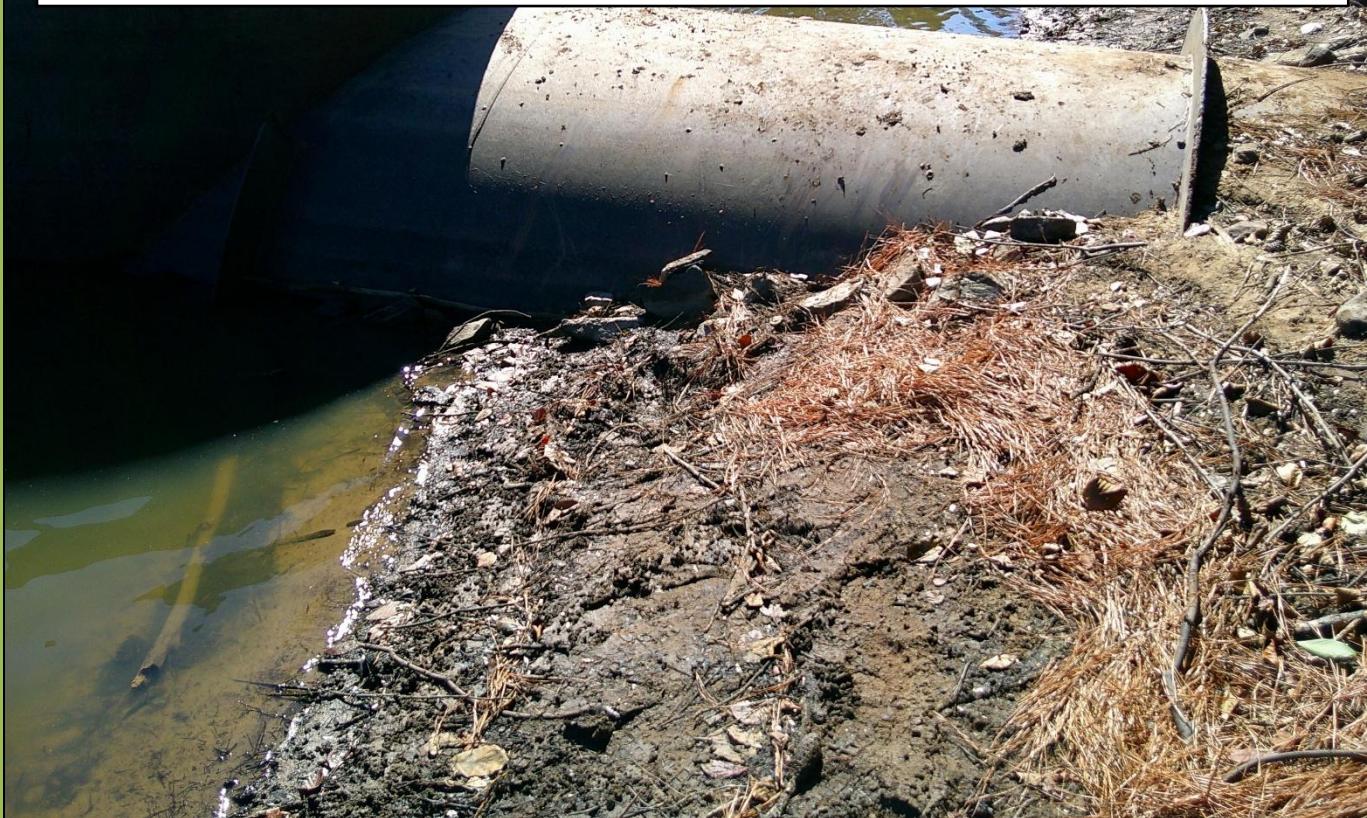
At the Spillway Pipe

General Comments: The area near the shoreline (that's typically several feet below normal pool) looked pretty good in terms of stability. At the spillway pipe, there were no evidences of piping (as seen by settlement or cave-ins). To watch an animated video that shows what happens when piping failure in a dam occurs, click or paste the following link [Piping Failure at Dams]: <https://www.youtube.com/watch?v=PC58mGG55io>.

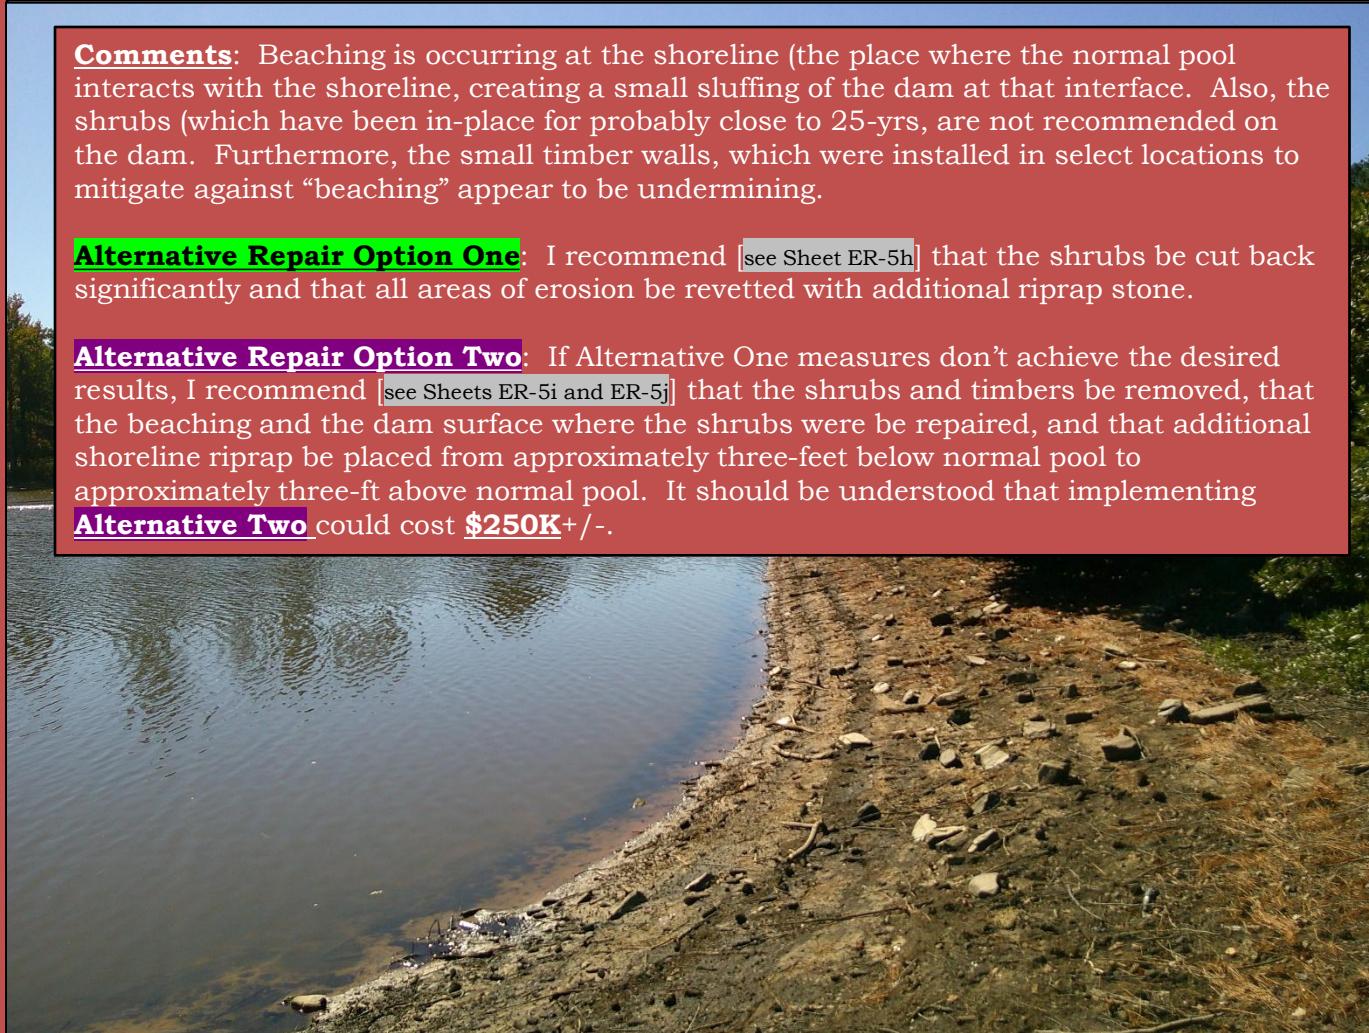
Comments: Beaching is occurring at the shoreline (the place where the normal pool interacts with the shoreline, creating a small sluffing of the dam at that interface. Also, the shrubs (which have been in-place for probably close to 25-yr), are not recommended on the dam. Furthermore, the small timber walls, which were installed in select locations to mitigate against “beaching” appear to be undermining.

Alternative Repair Option One: I recommend [see Sheet ER-5h] that the shrubs be cut back significantly and that all areas of erosion be revetted with additional riprap stone.

Alternative Repair Option Two: If Alternative One measures don't achieve the desired results, I recommend [see Sheets ER-5i and ER-5j] that the shrubs and timbers be removed, that the beaching and the dam surface where the shrubs were be repaired, and that additional shoreline riprap be placed from approximately three-feet below normal pool to approximately three-ft above normal pool. It should be understood that implementing **Alternative Two** could cost **\$250K+/-**.

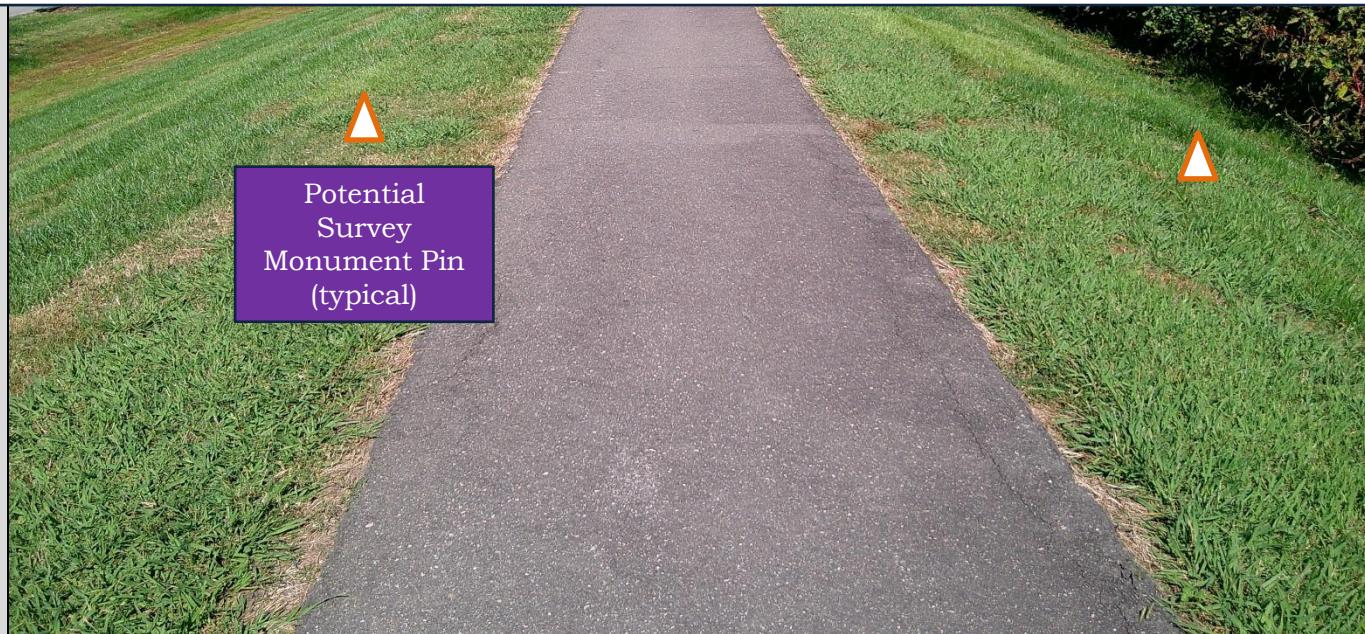
Moving Northward

General Comments: The portion of the dam that sits above Woodcroft PW is generally in good shape and well-vegetated. Manual probings with a 48" utility probe rod found that the dam appeared to be very tight and well-compacted. There's an area on the d/s face near the northern abutment that needs some attention (in terms of the establishing of turf grass). In addition, the ditch on the downstream side is experiencing some distress due to marginal original construction and marginal stabilization attempts (probably by the City of Durham). As with all dams, settlement occurs as the dam consolidates. In walking the whole dam, I noted areas of settlement. To monitor such "settlement" and to make sure it's not indicative of something "bad" happening below the surface, I recommend setting two rows of survey monument pins (at 100-ft increments) along the top of the dam approximately two feet west of the trail edge and on the u/s face approximately 10-ft east of the trail edge. In addition, since this device doesn't appear to include seepage control measures, it would be prudent to consider establishing some piezometers near the top of the dam and about halfway down the downstream slope. I'd place them approximately 30-ft on each side of the spillway pipe [see Sheet ER-5n]. Piezometers can be helpful in monitoring the migration of seepage through the dam. All dams seep; in the industry, we call it "phreatic flow." In many ways, the phreatic surface in a dam is like an artificial water table.
