**WOODLAKE HOMEOWNERS
ASSOCIATION
DURHAM, NC**

APRIL 23, 2025

FULL RESERVE STUDY

**GILES FLYTHE
ENGINEERS**

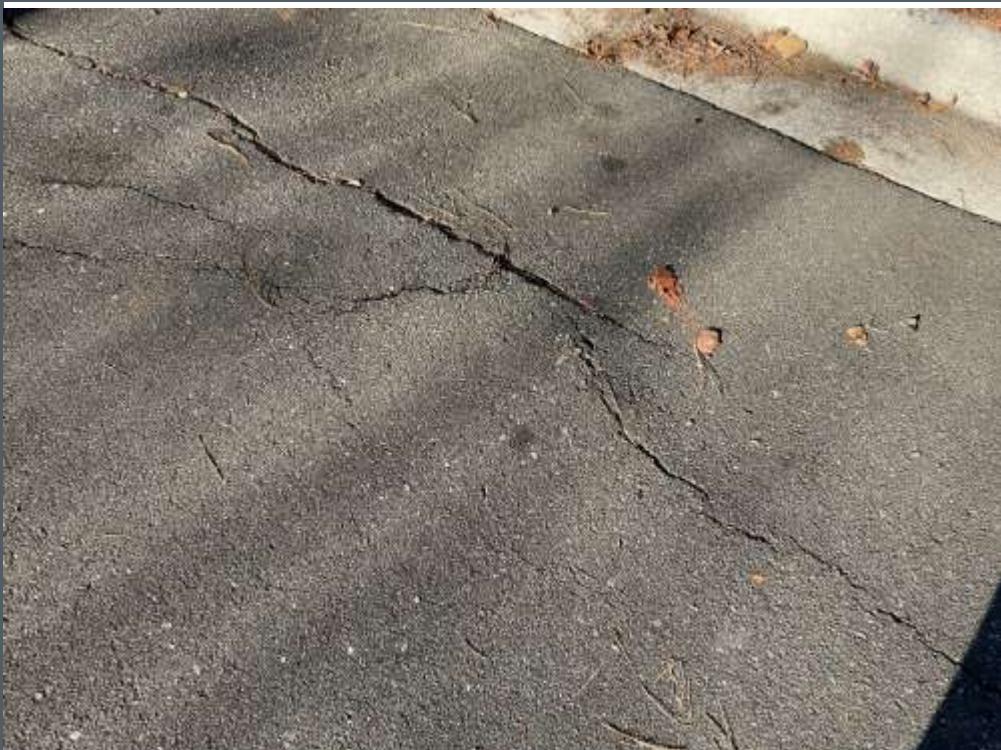
Photo No. 2

The clubhouse parking lot generally appeared to be in good condition with minor cracking and fading striping noted. Typically, we recommend the application of an oil-resistant sealant to all asphalt paved surfaces on an approximately 5-year cycle. At this same time, all cracks should be properly filled, patched, and sealed, and lines restriped. We have allocated funds for restriping, crack repairs, and sealing the asphalt paving at the clubhouse parking lot on a 5-year cycle beginning in 2026.

Fading striping at
amenity center parking
lot.

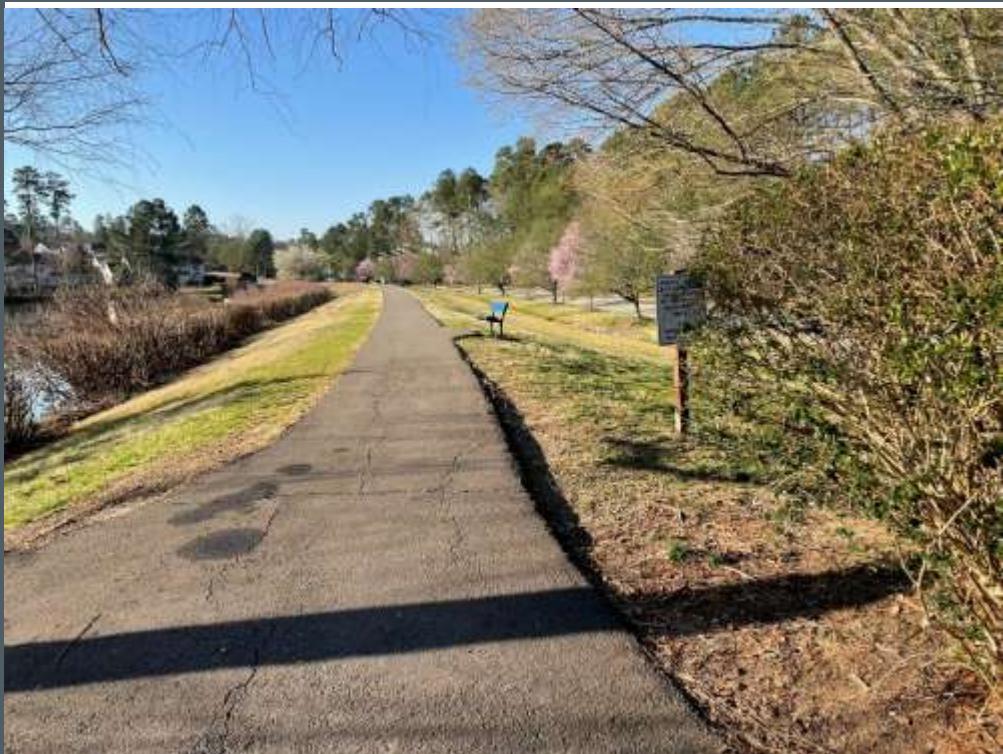
Photo No.
4

Heaving along asphalt
paved walking trail.

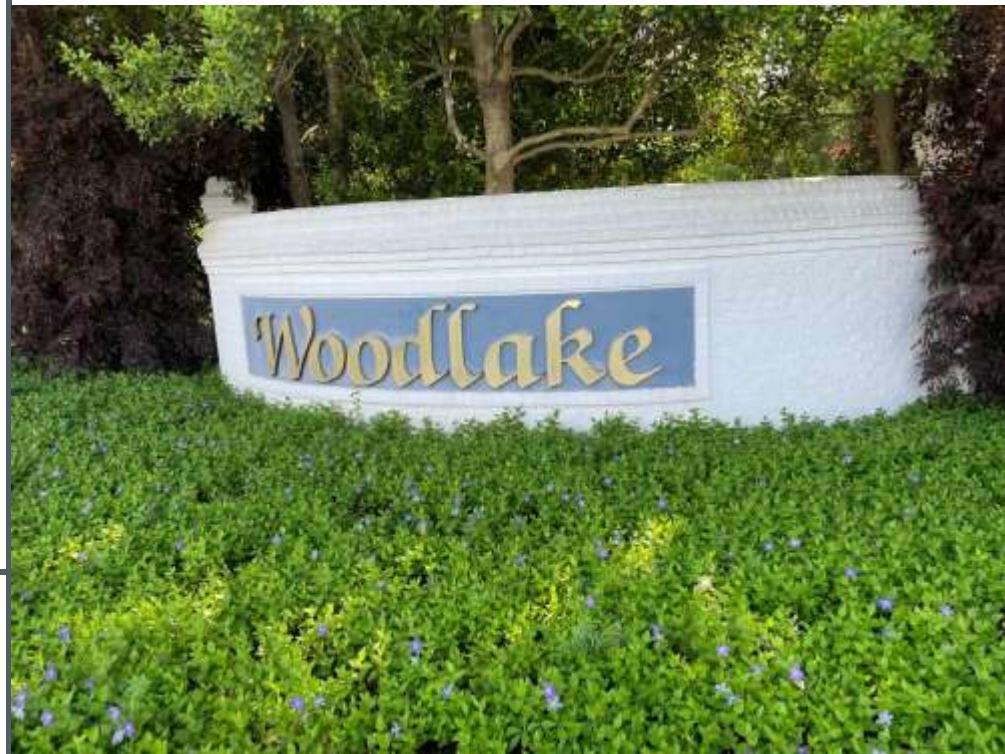
Monument entrance signage is located at the primary entrance to the community and generally consists of painted masonry monument structures with inlaid metal signs bearing the community's name. The entrance monuments are standing in landscape beds and generally appeared to be in good condition with fading and flaking paint noted on the signs. Smaller but similarly constructed entrance monuments are located at the secondary entrances where E. Woodcroft Pkwy intersects Woodlake Dr and where Barbee Rd intersects Forest Ridge Dr. We do not anticipate a large-scale replacement project of the monuments; however, refurbishment may be periodically required. Refurbishment may include replacement/repairs of the signage, repainting, and repairs to the masonry structures. We have included an allocation of funds for repairs to the entrance monuments and lighting every 15 years beginning in 2026.

Discoloration and signs of wear on entrance sign.

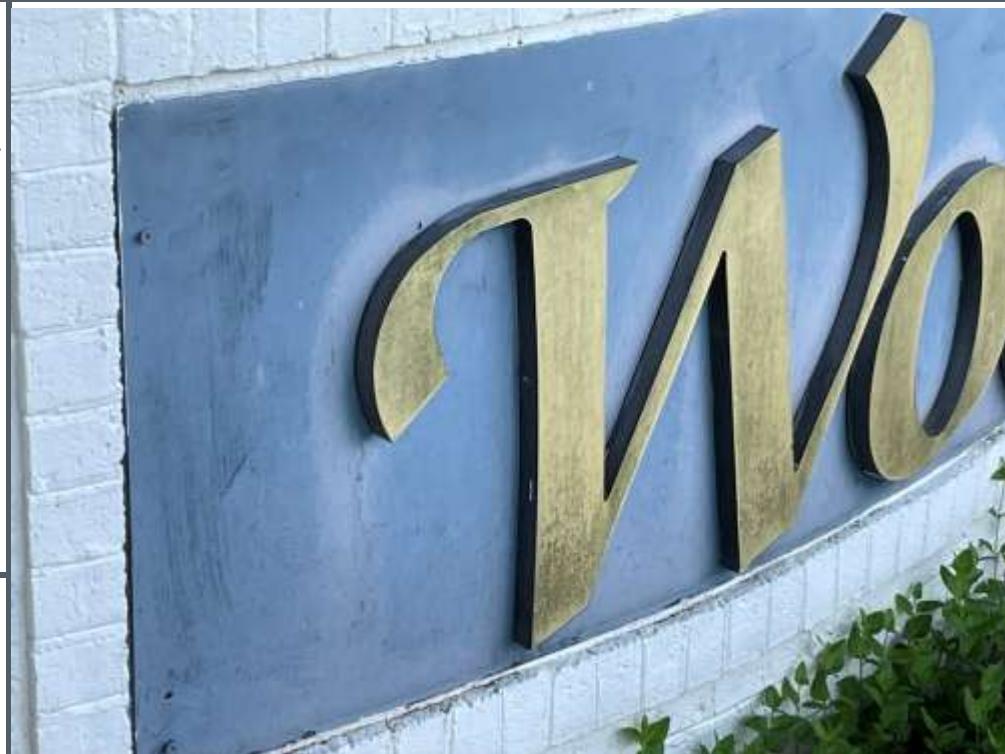
16

Flaking paint on entrance signage.

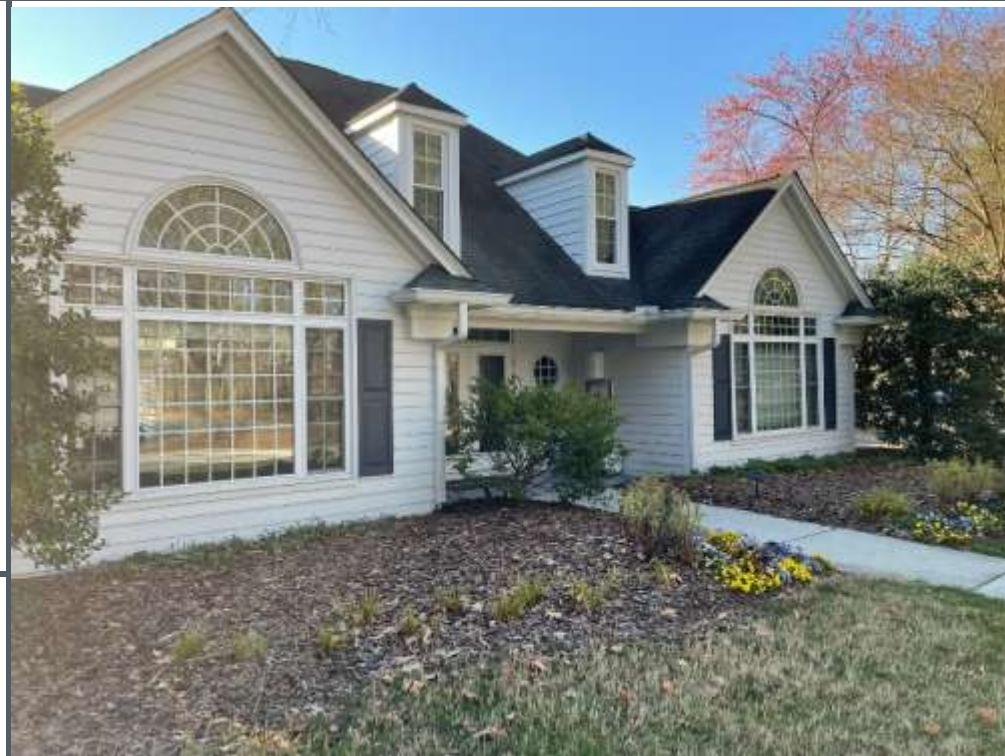
Photo No.
21

The predominant pitched roof surfaces over the buildings are comprised of asphaltic fiberglass architectural grade roof shingles. Roof surfacing is applied over roof sheathing, and appears to be in relatively good condition. We are unaware of any concerns with current or previous roof leaks. Periodic minor repairs to the vent boots, flashings and gutters will likely begin to be required in the near term. We have assumed these minor repairs would be funded from an annual maintenance budget.

Architectural grade
shingle roof.

Assuming minor repairs are completed as needed in the interim, we estimate the roofing to have an expected remaining useful life of approximately 10 years and have allocated funds to replace the roofs in 2036. We strongly recommend that any re-roofing project closely follow procedures outlined by the latest edition of the National Roofing Contractors Association's *Roofing and Waterproofing Manual*. A re-roofing sequence should include removal of the existing roofing material, replacement of any inadequate roof sheathing, replacement of any damaged flashing, and replacement of drip edge components.

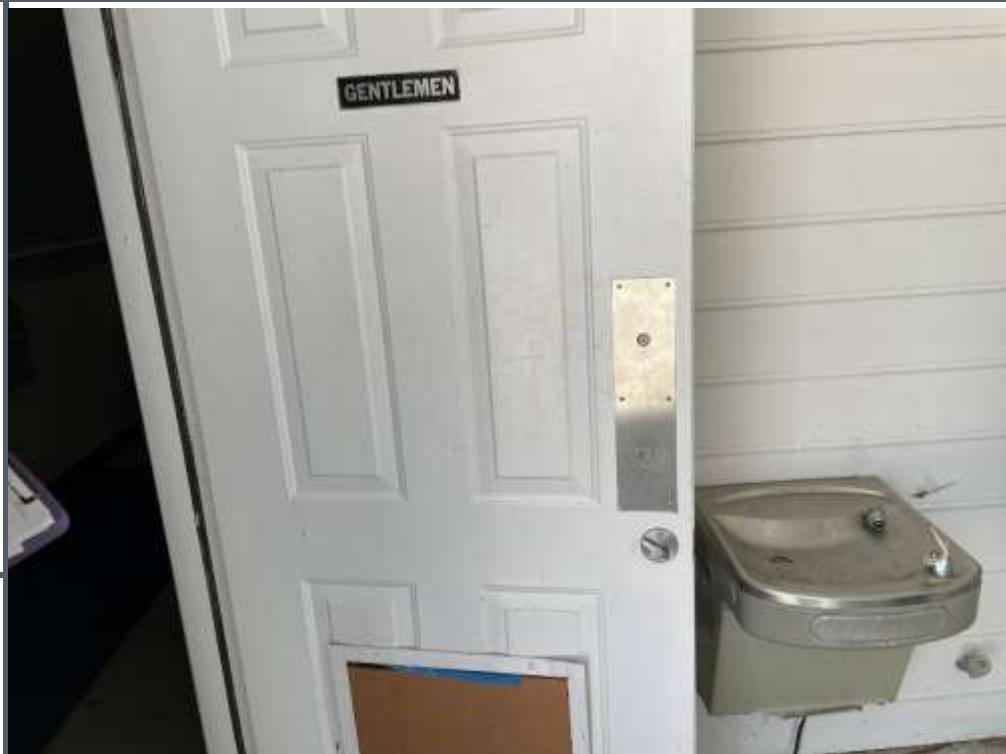
Photo No.
24

Painted metal-skin doors provide access to the pool equipment room and bathhouse. Due to exposure and corrosion, these doors have an expected useful life of approximately 15 years. We have included funds to replace the doors every 15 years beginning in 2026.

Rust on bathhouse metal door.

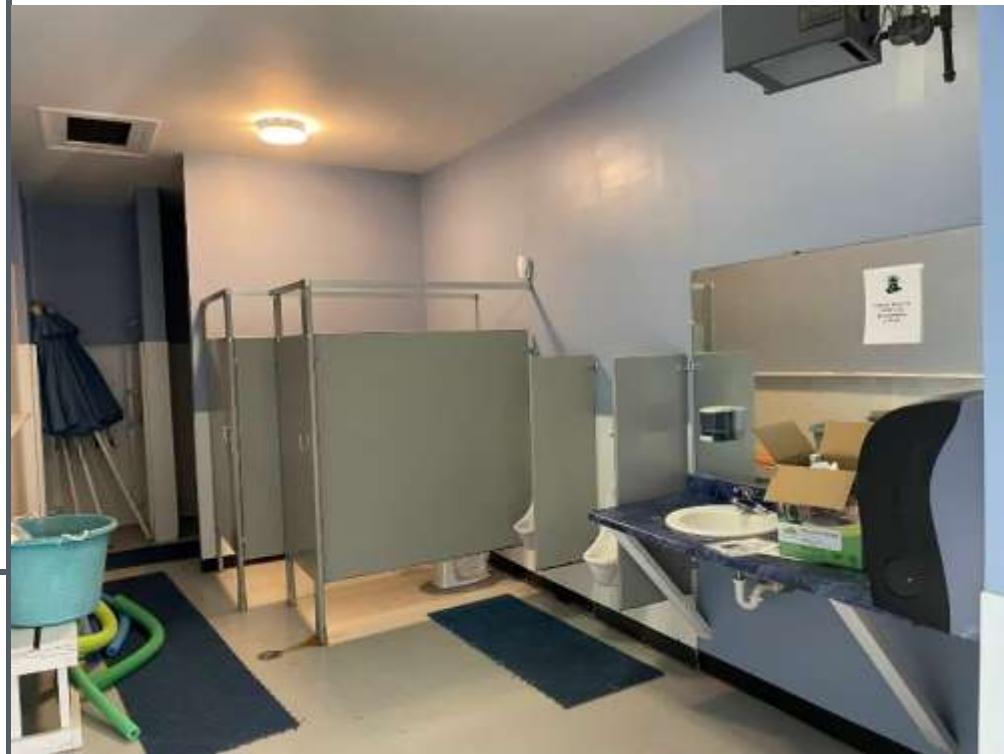
Photo No.
31

The bathhouse includes men's and women's restrooms with toilet and urinal stalls, showers, partitions, and sinks with countertops. The bathroom finishes generally appeared to be in fair condition with rust noted at the base of the partitions. We have allocated funds to refurbish the bathhouse restrooms on a 25-year cycle beginning in 2028.

Rust at base of stall partitions.
