Woodlake Dam and Outlet Works Evaluation

October 27, 2025

WDL-2025-10-18

Executive Summary

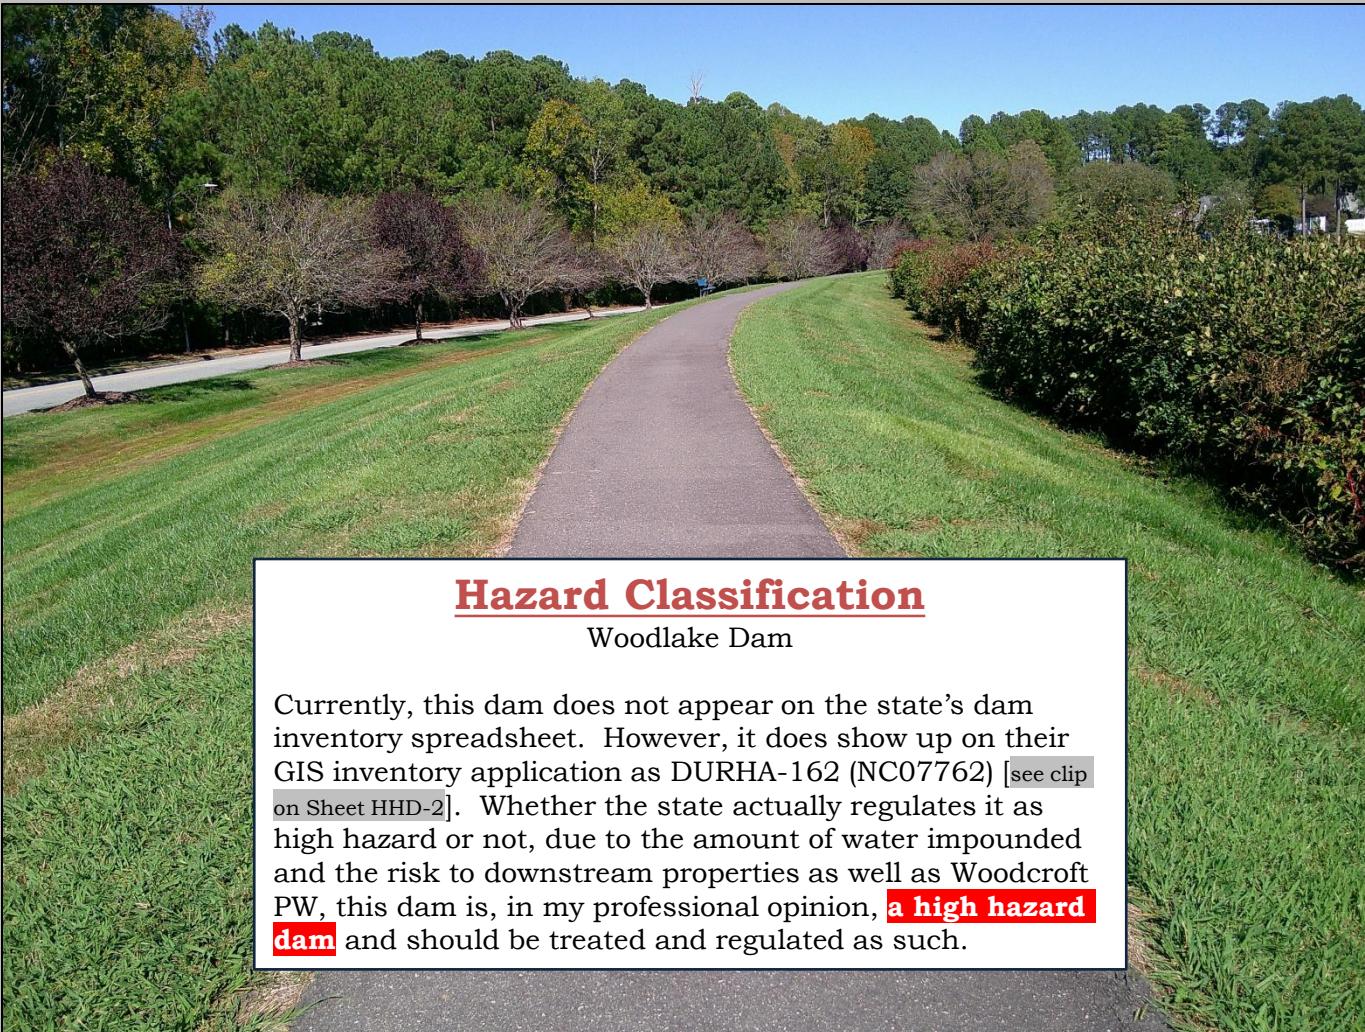
Hazard Classification

Currently, this dam does not appear on the state's dam inventory spreadsheet. However, it does show up on their GIS inventory application as DURHA-162 (NC07762) [see clip on Sheet HHD-2]. Whether the state actually regulates it as high hazard or not, due to the amount of water impounded and the risk to downstream properties as well as Woodcroft PW, this dam is, in my professional opinion, **a high hazard dam** and should be treated and regulated as such.

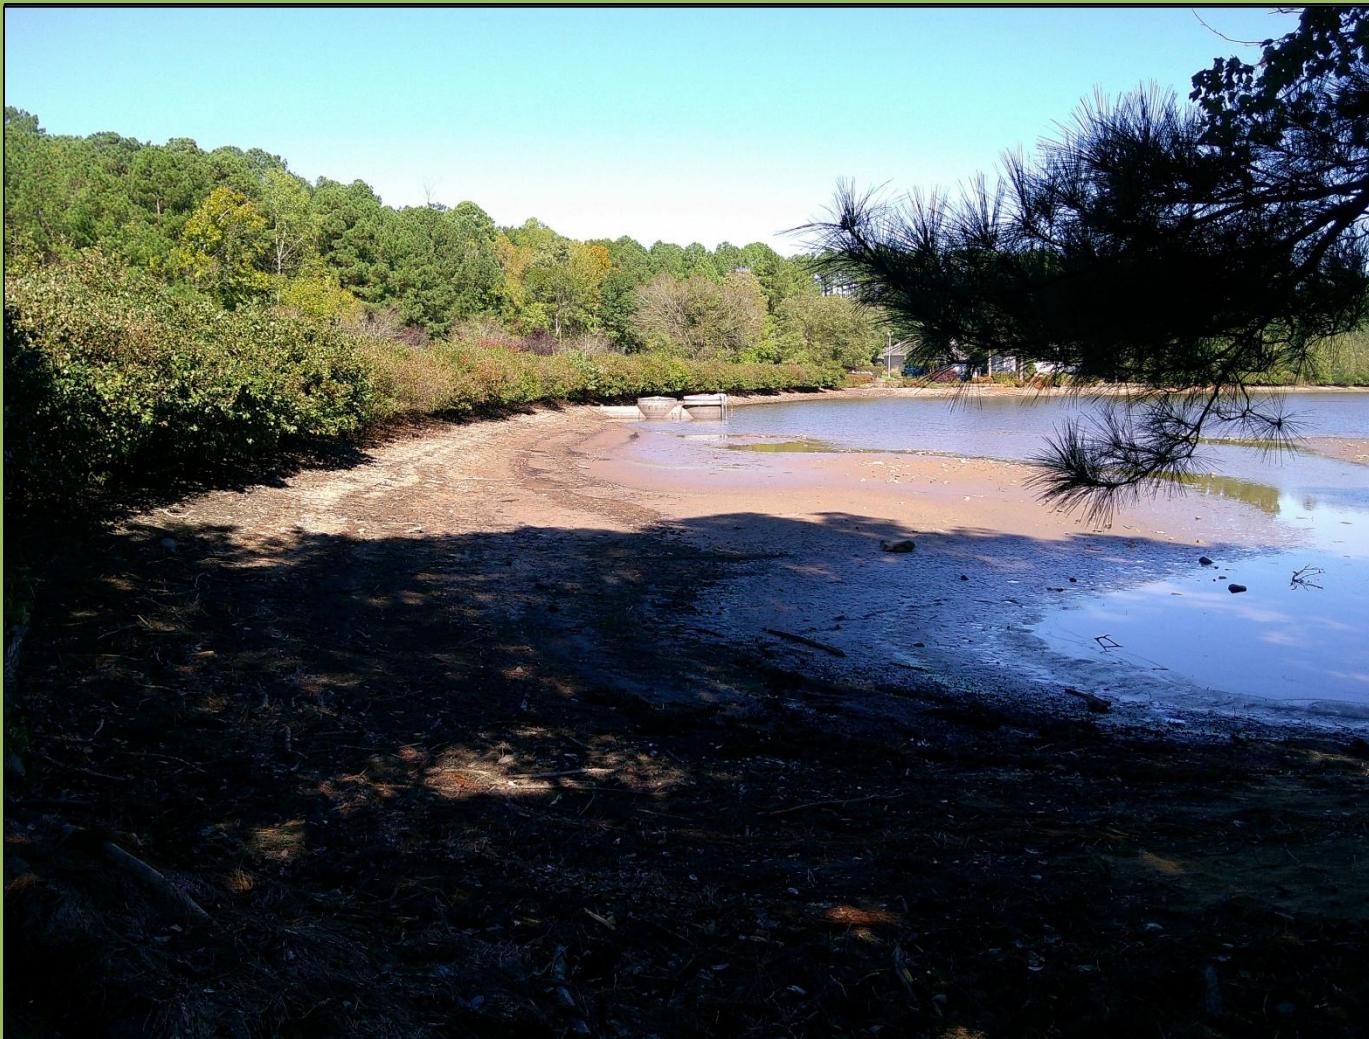
Southern Side (looking northward)

General Comments: The area near the shoreline (that's typically several feet below normal pool) looked pretty good in terms of stability. At the spillway pipe, there were no evidences of piping (as seen by settlement or cave-ins). To watch an animated video that shows what happens when piping failure in a dam occurs, click or paste the following link [Piping Failure at Dams]: <https://www.youtube.com/watch?v=PC58mGG55io>.

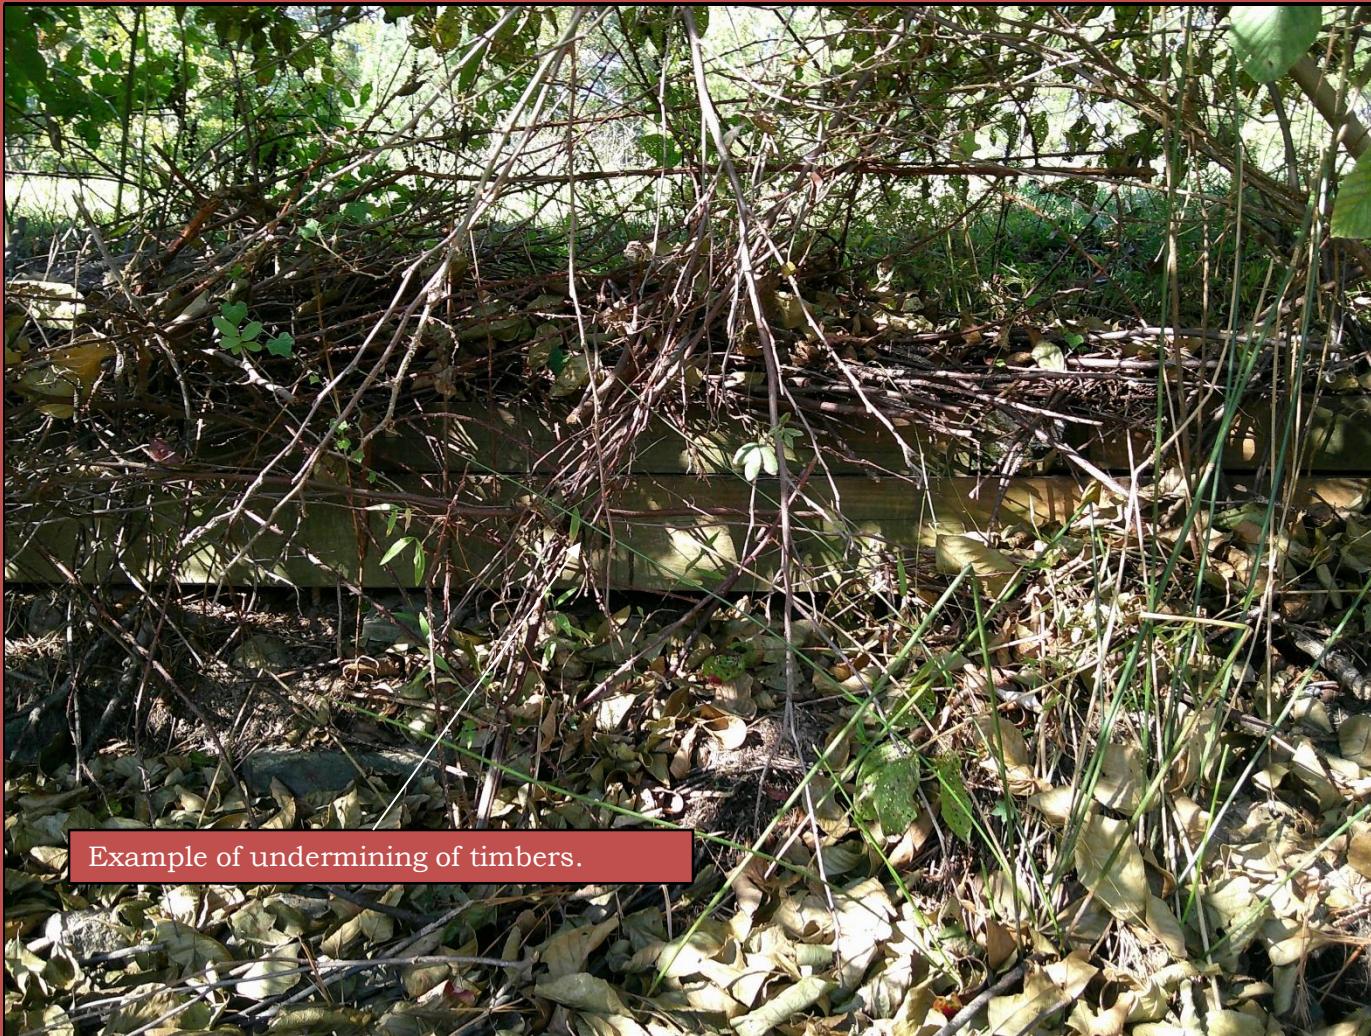
Comments: Beaching is occurring at the shoreline (the place where the normal pool interacts with the shoreline, creating a small sluffing of the dam at that interface. Also, the shrubs (which have been in-place for probably close to 25-yr), are not recommended on the dam. Furthermore, the small timber walls, which were installed in select locations to mitigate against “beaching” appear to be undermining.

Alternative Repair Option One: I recommend [see Sheet ER-5h] that the shrubs be cut back significantly and that all areas of erosion be revetted with additional riprap stone.

Alternative Repair Option Two: If Alternative One measures don't achieve the desired results, I recommend [see Sheets ER-5i and ER-5j] that the shrubs and timbers be removed, that the beaching and the dam surface where the shrubs were be repaired, and that additional shoreline riprap be placed from approximately three-feet below normal pool to approximately three-ft above normal pool. It should be understood that implementing **Alternative Two** could cost **\$250K+/-**.

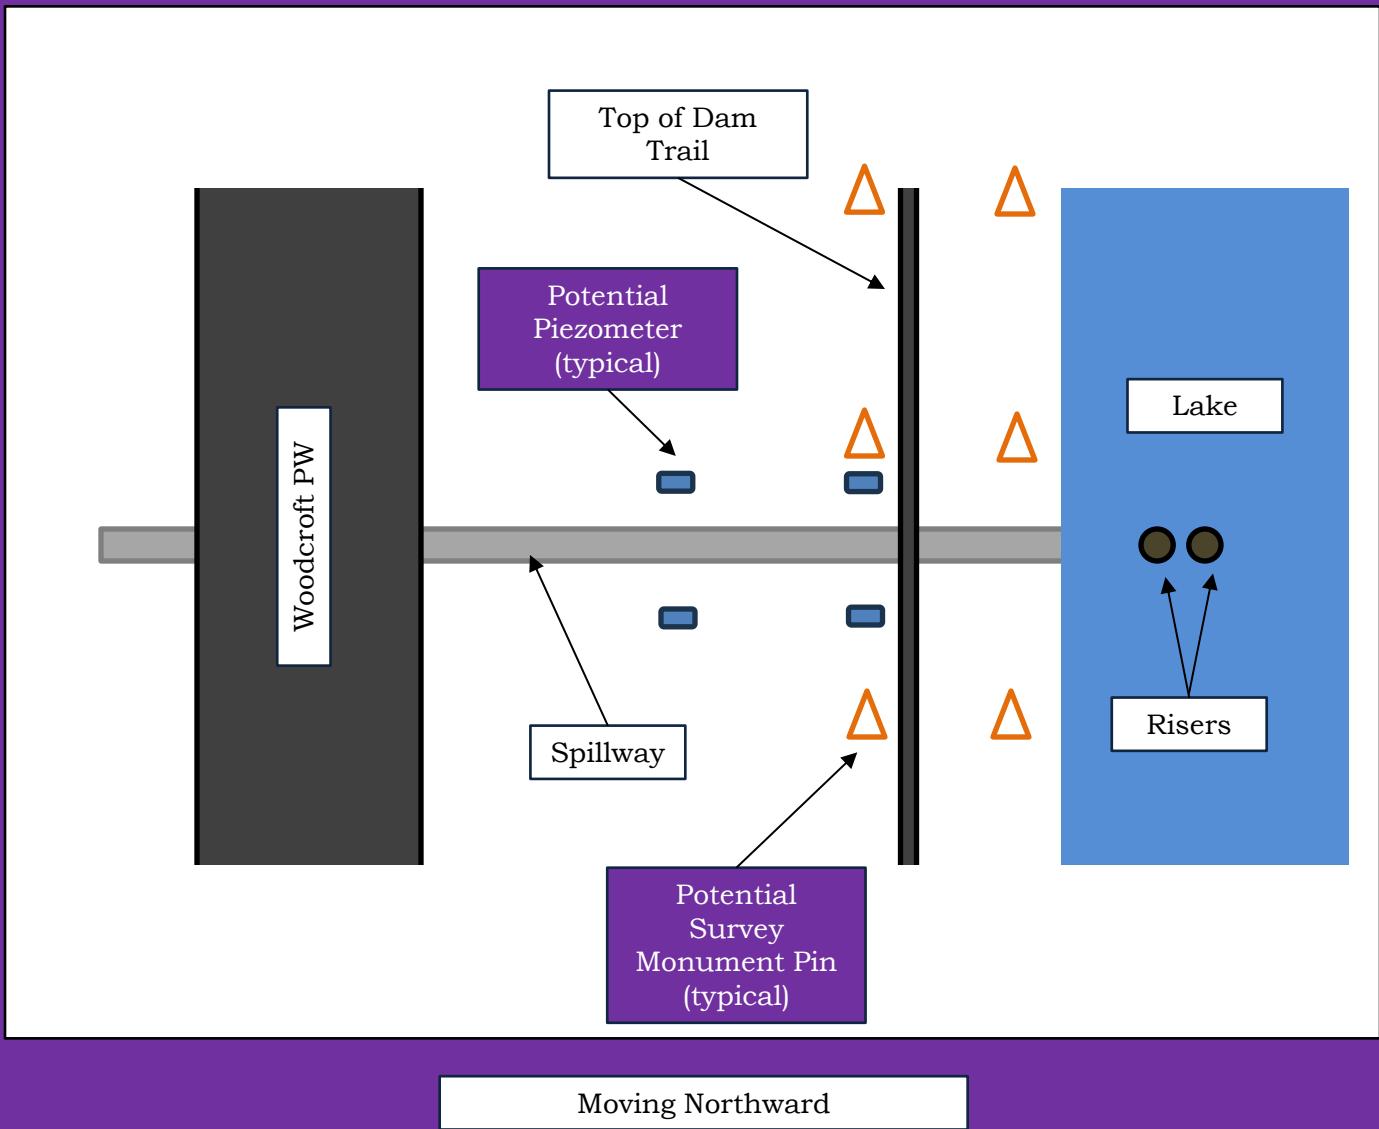
General Comments: The portion of the dam that sits above Woodcroft PW is generally in good shape and well-vegetated. Manual probings with a 48" utility probe rod found that the dam appeared to be very tight and well-compacted. There's an area on the d/s face near the northern abutment that needs some attention (in terms of the establishing of turf grass). In addition, the ditch on the downstream side is experiencing some distress due to marginal original construction and marginal stabilization attempts (probably by the City of Durham). As with all dams, settlement occurs as the dam consolidates. In walking the whole dam, I noted areas of settlement. To monitor such "settlement" and to make sure it's not indicative of something "bad" happening below the surface, I recommend setting two rows of survey monument pins (at 100-ft increments) along the top of the dam approximately two feet west of the trail edge and on the u/s face approximately 10-ft east of the trail edge. In addition, since this device doesn't appear to include seepage control measures, it would be prudent to consider establishing some piezometers near the top of the dam and about halfway down the downstream slope. I'd place them approximately 30-ft on each side of the spillway pipe [see Sheet ER-5n]. Piezometers can be helpful in monitoring the migration of seepage through the dam. All dams seep; in the industry, we call it "phreatic flow." In many ways, the phreatic surface in a dam is like an artificial water table.

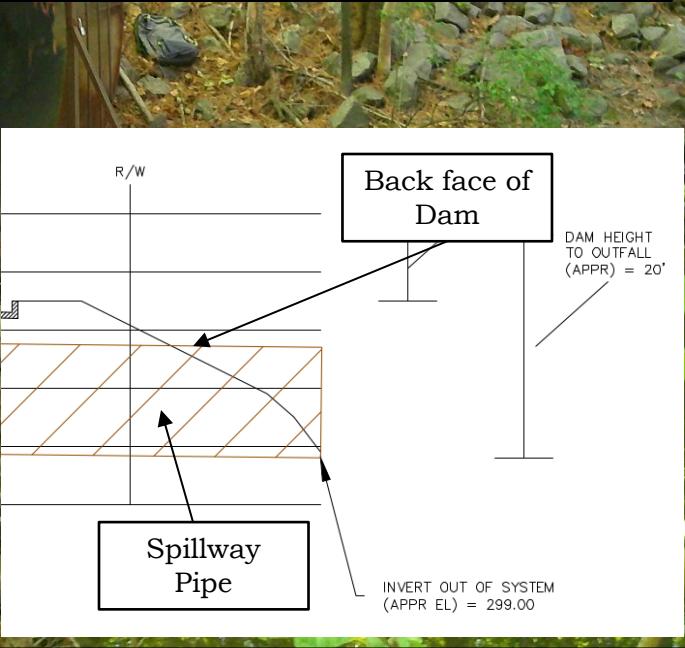
Comments: I recommend removing all 6" dia (or less) trees over the pipe or within 20-ft of each side of the pipe is recommended. For now, while I recommend leaving the larger trees in-place. These larger trees should be monitored for any apparent damage they may be causing to the pipe or the back face of the dam. Eventually, the idea here will be to try to get grass growing over the pipe (s opposed to forest).
